**NORWAY/UNITED STATES DESIGN PROTECTIVE
AIRCRAFT SHELTER (PAS) QUANTITY-DISTANCE
PROGRAM 1/3-SCALE TEST SERIES**

**Volume I of V
PAS 1-4 Summary**

Final Report

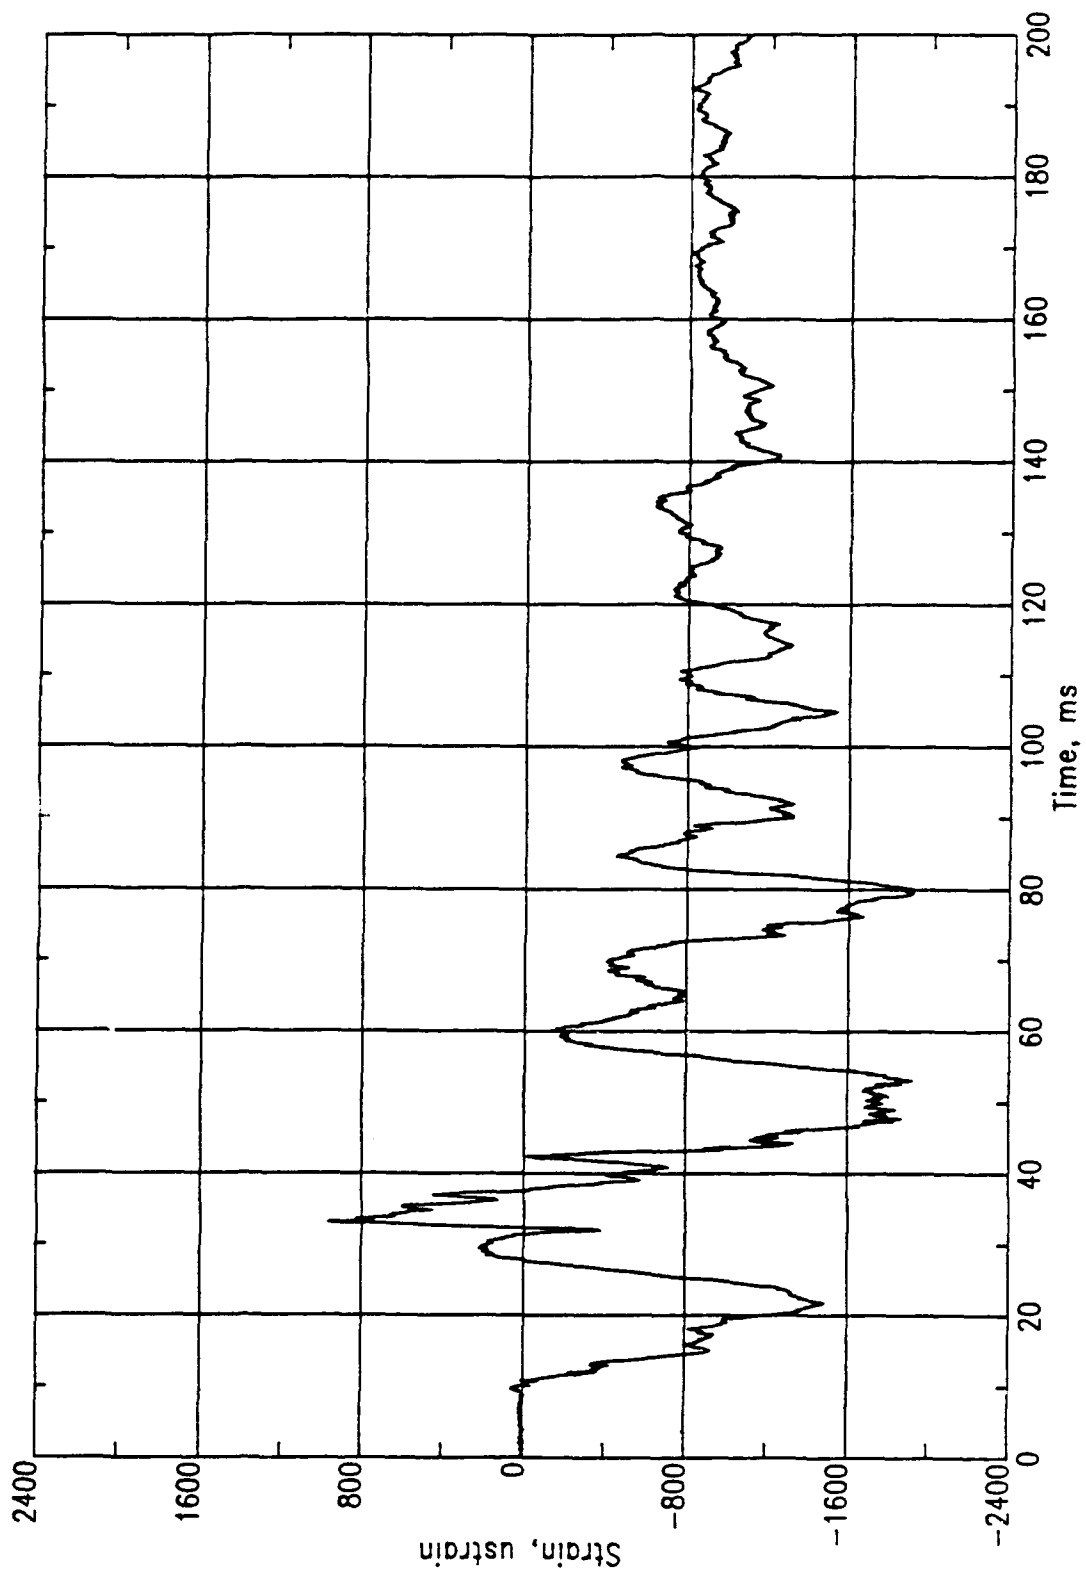
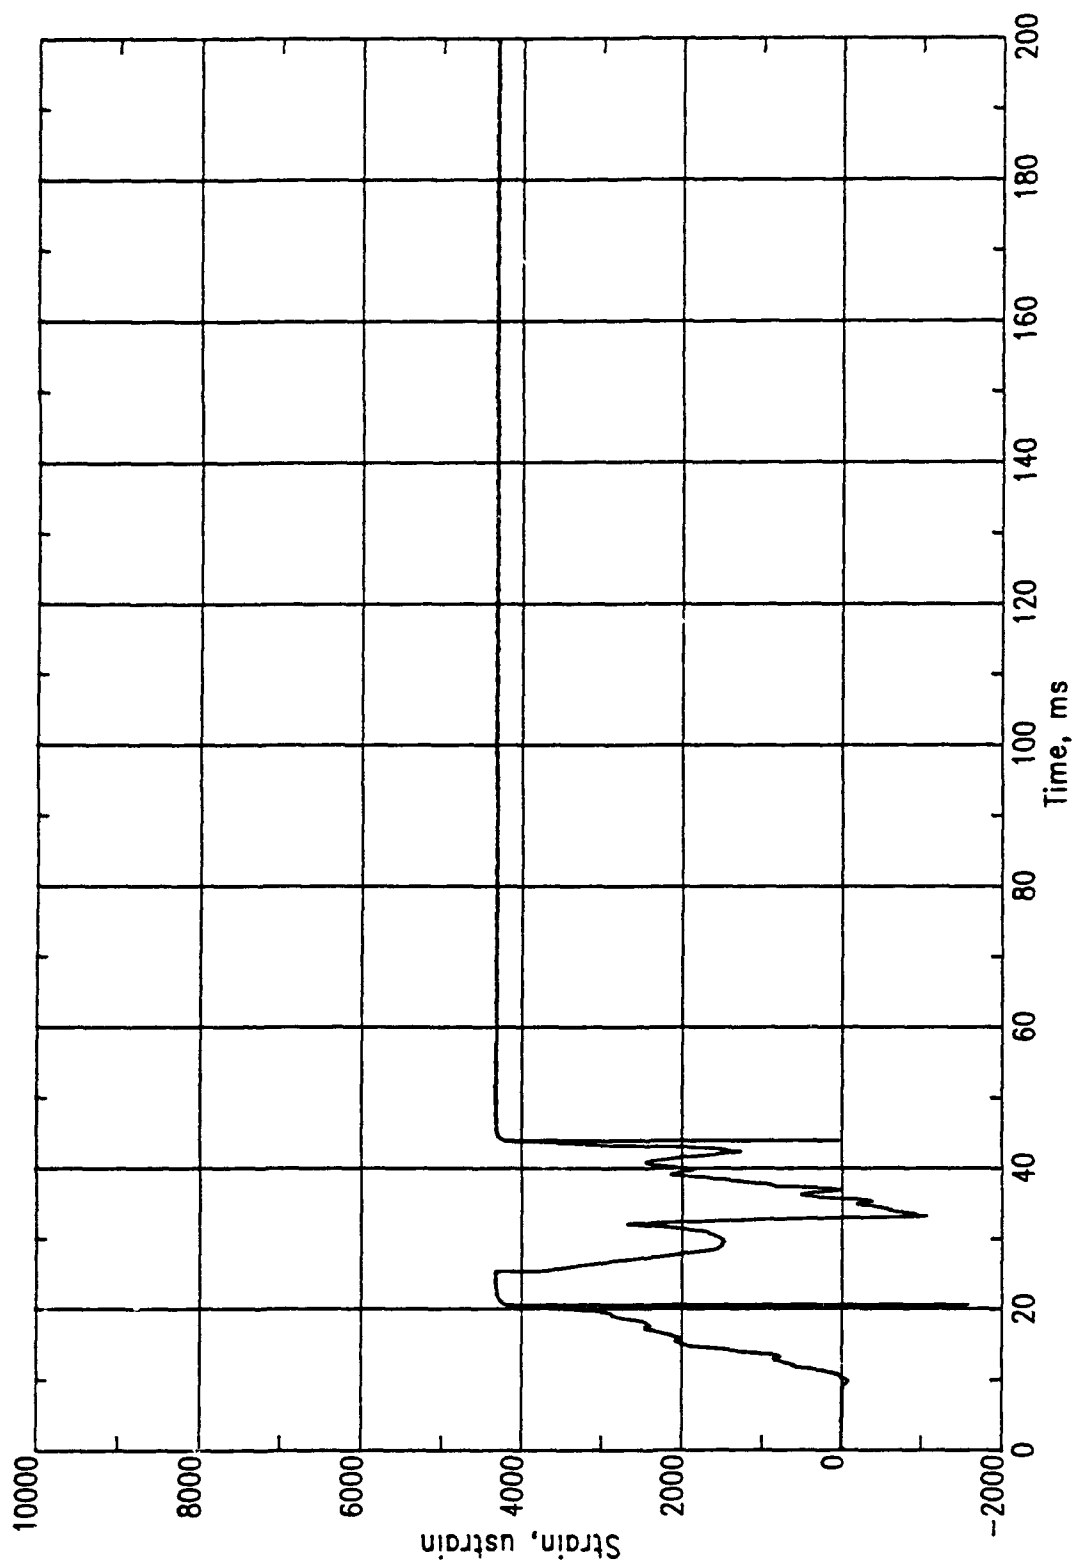
Figure 52. PAS-1, MN 3402.

Vertical strains measured at the center of the door are at least consistent with the outward bending of the door. Measurement Number 3402 (Fig. 52) shows a tensile strain of 1500 microstrain in the outer plate at 21.7 ms. At about the same time MN 3404 (Fig. 53) exceeded its recording bandwidth, but it shows a compressive strain in excess of 4300 microstrain in the inner plate. The higher compressive strains in the inner plate would normally indicate an axial compressive force had been applied to the door; however, this does not appear to be a probable explanation for this measurement discrepancy. Measurement Number 3402 shows a residual tensile strain of about 800 microstrain.

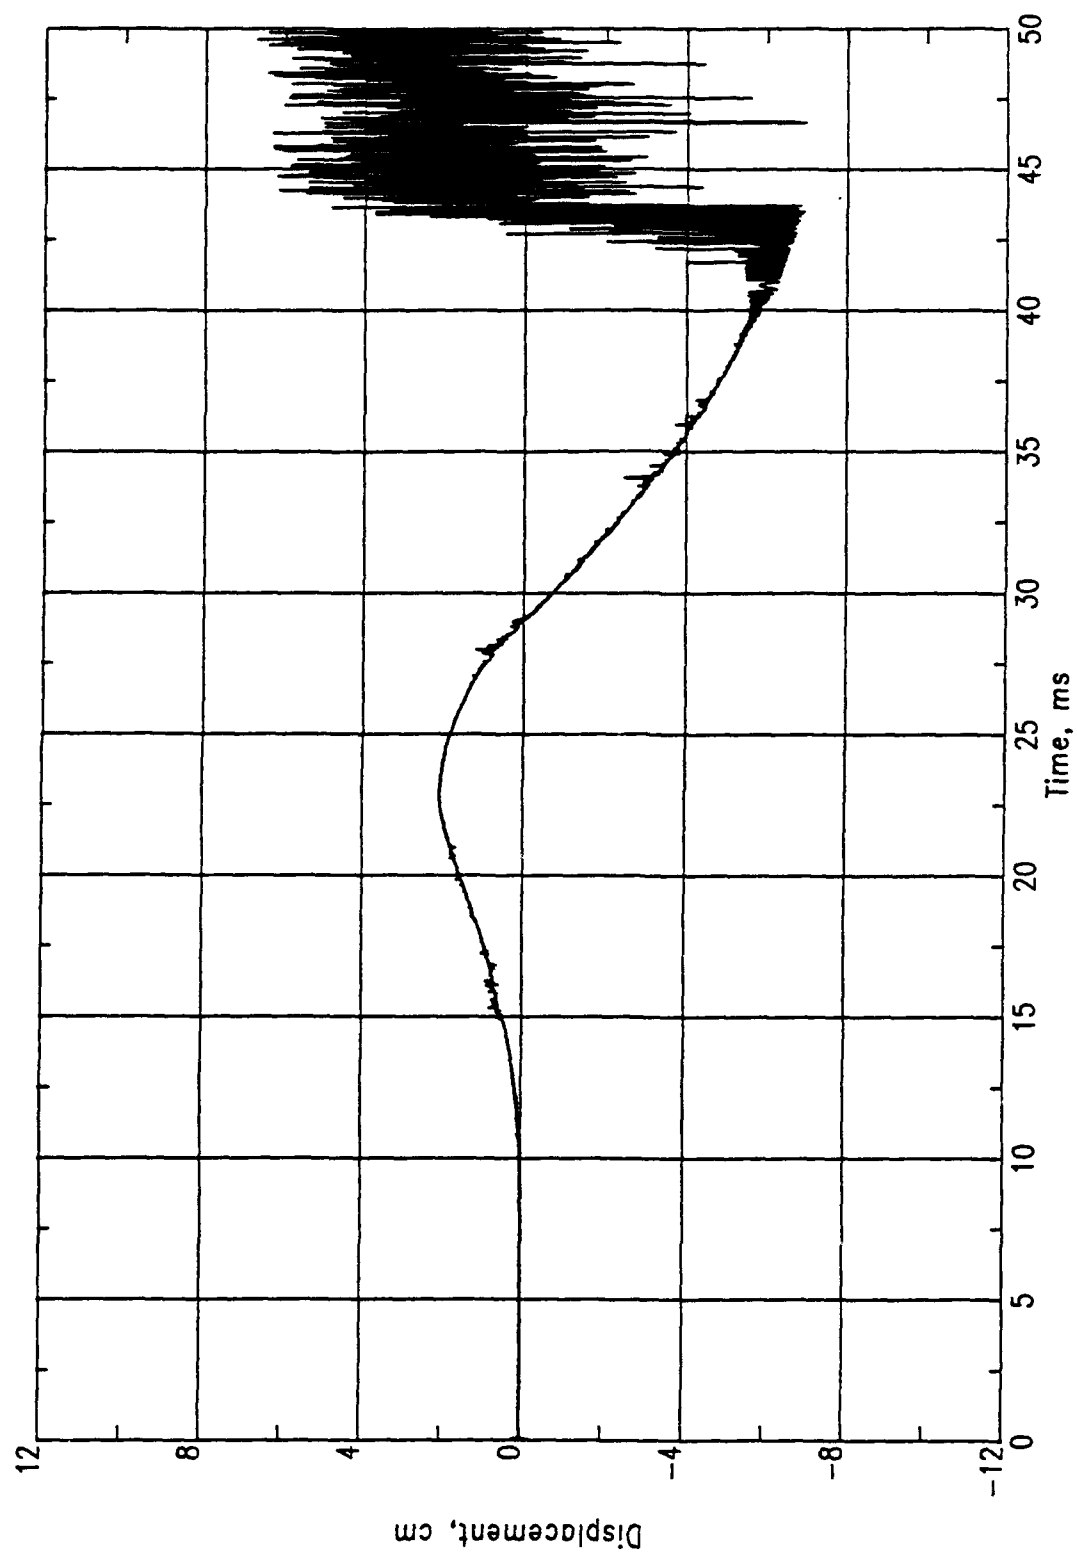
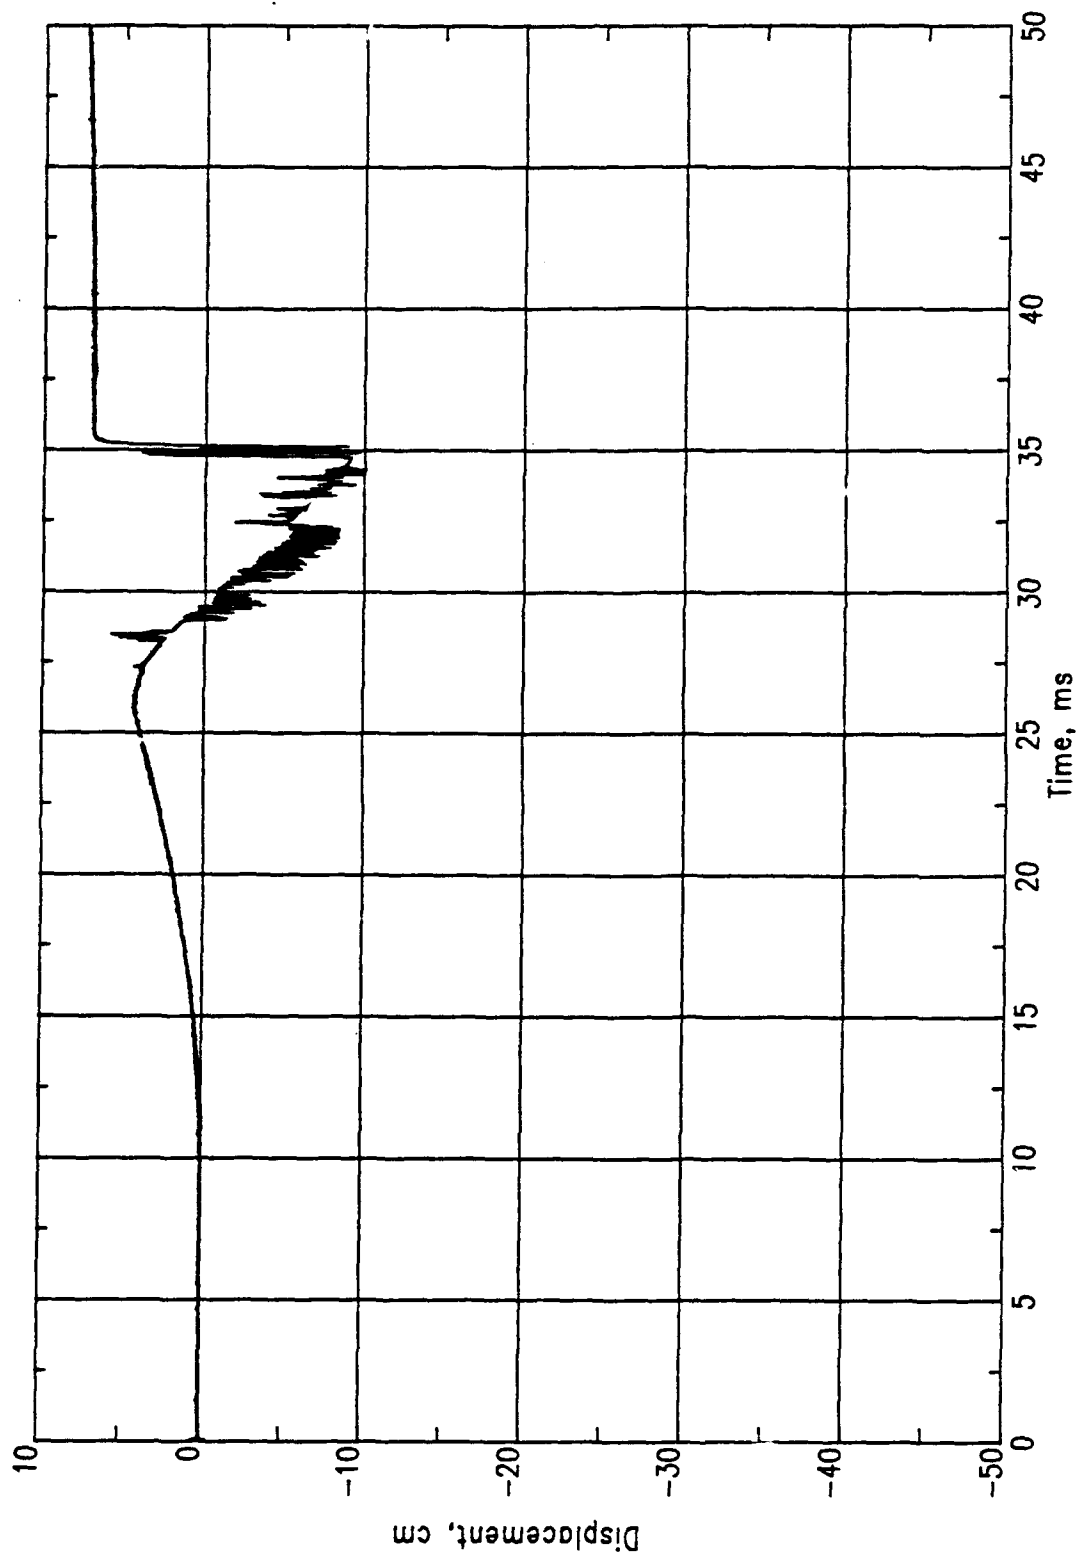
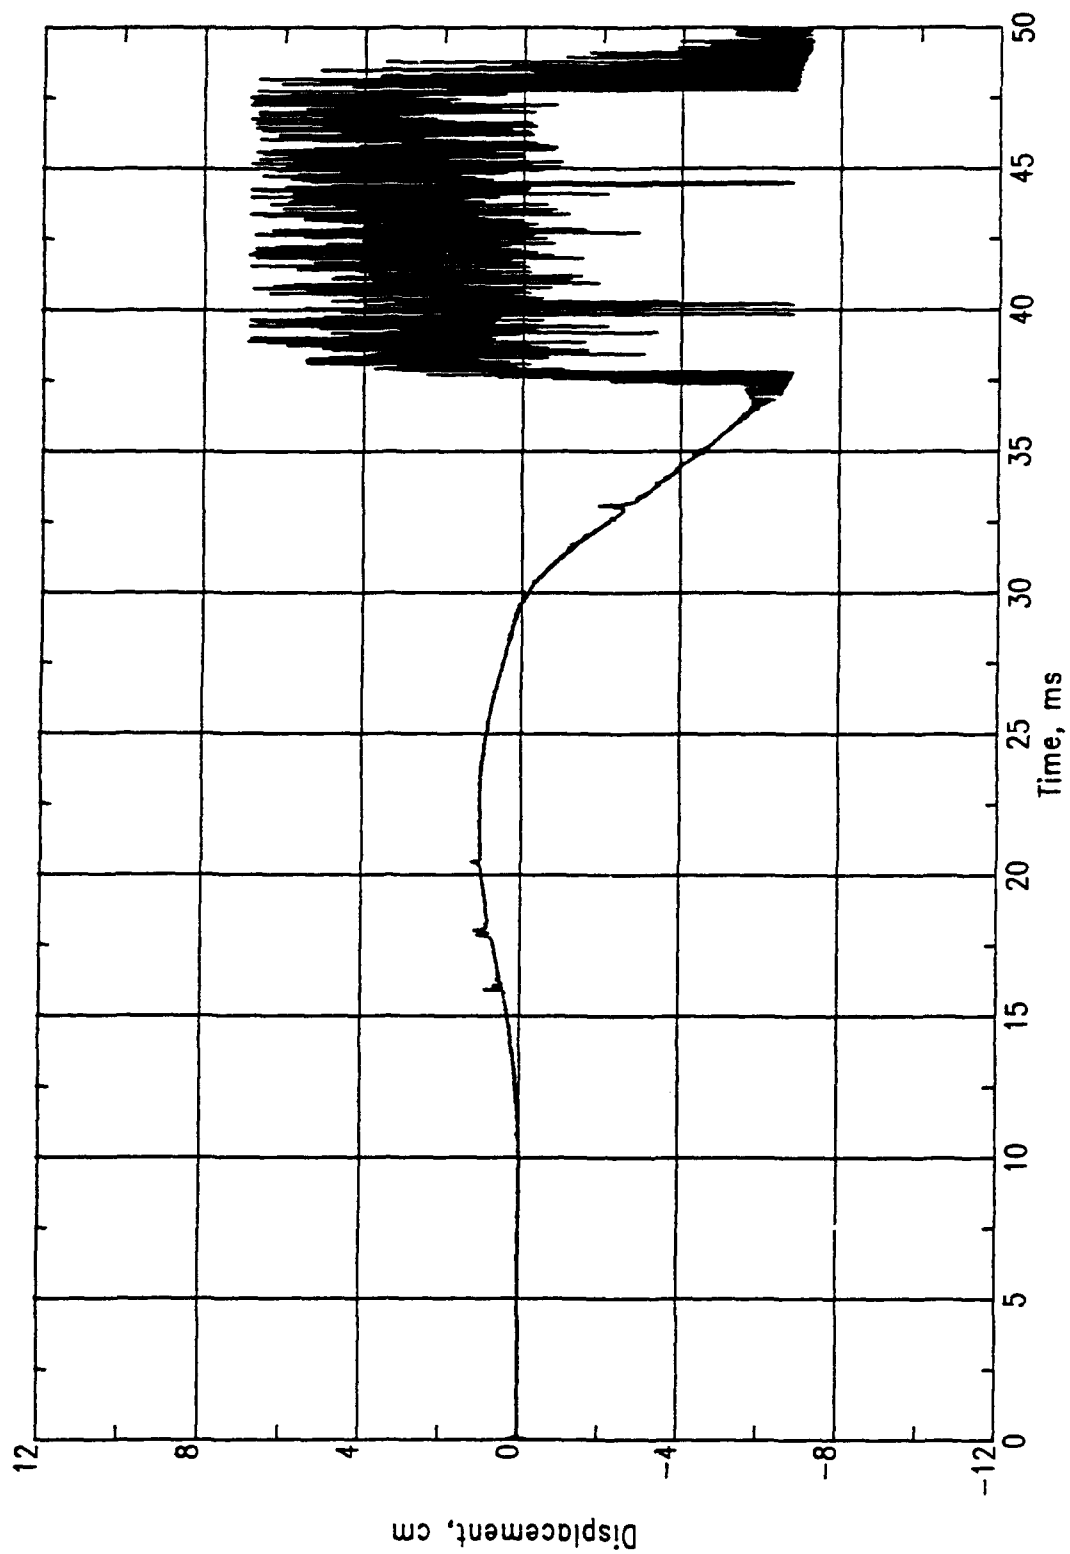
Figure 54. PAS-1, MN 7401.

Three displacement gages were attached to the front door in a vertical line at its centerline. Measurement Number 7401 (Fig. 54) was attached near the top of the door and showed a peak outward displacement of 2.03 cm at 22.5 ms. Measurement Number 7402 (Fig. 55) attached at mid-height of the door showed a peak outward displacement of 2.79 cm at 26.5 ms, and MN 7403 (Fig. 56) at the bottom of the door showed a peak displacement of 0.98 cm at 22.0 ms. The door appears to have fallen from its supports and into the shelter at 30 to 40 ms, and inward displacements recorded after this time are questionable.

The front door rigid body response observed in PAS-1 would probably not occur in the full-size structure. There are significant differences between the model structure and the full-size shelter in the system that supports the door in the closed position. The door in the full-size shelter is raised and lowered by a cable and pulley system attached to each side of the door near its upper edge. When the door is in the raised and locked position, the cables are slacked off, but remain attached to the door. In the raised position the door rests on a short post at each side of the door. These posts keep the front door in a slot in the parapet and restrained against lateral loads. The posts that hold the door in the slot in the parapet of the full-size shelter are themselves secured in place by a system of hinge pins, springs, and hydraulic rams. These elements hold the

posts securely in position under the raised door. These door-raising and post-positioning elements were not included in the model. When the model door began moving under internal blast loading in the PAS-1 event, the two posts apparently fell out of position, allowing the door to drop out of the parapet slot and into the shelter.

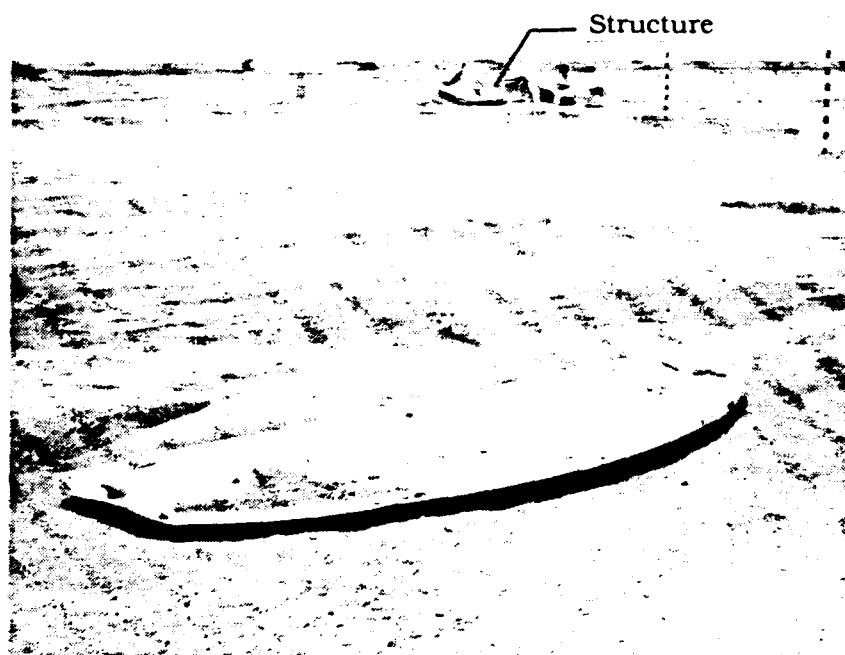
Figure 74. Front door, PAS-3.

The door was bent its full width about a horizontal line with a maximum permanent deflection of 185 mm at the center. The edges at both sides of the door were also bent inward at approximately 140 mm. The inside plate was dished inward between each of the vertical ribs. The inside plate was also buckled in a 700 mm wide band along the horizontal centerline (Fig. 74b).

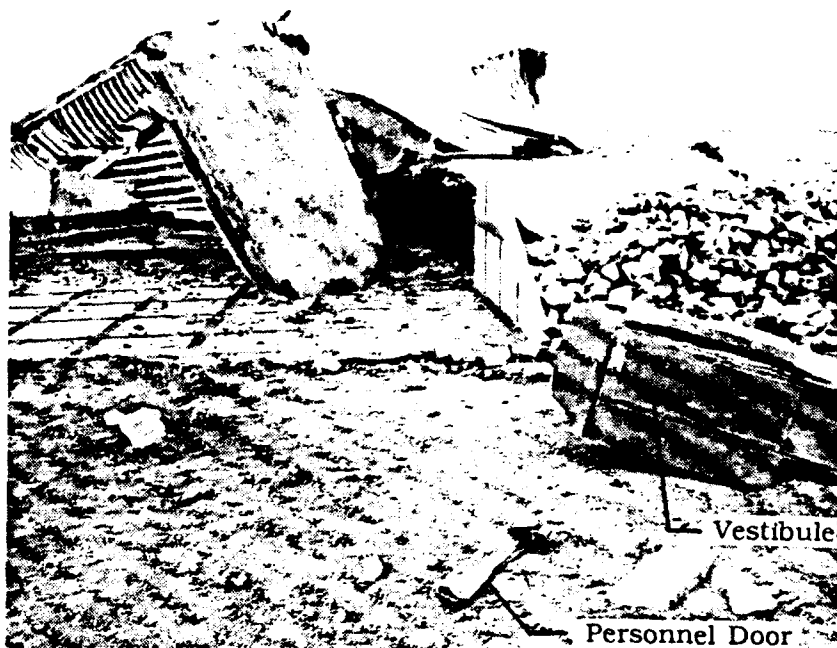
The personnel entrance vestibule was found intact, approximately 2.6 m in front of the left wingwall (Fig. 75). The personnel door, which had been located in a frame installed in the opening in the left front wall, was found near the vestibule. The door was bent in half about its vertical centerline (Fig. 75). All the welds simulating the door hinges and latches were broken. The door frame remained welded to the steel liner (Fig. 76).

Figure 75. Vestibule and personnel door (foreground), PAS-3.

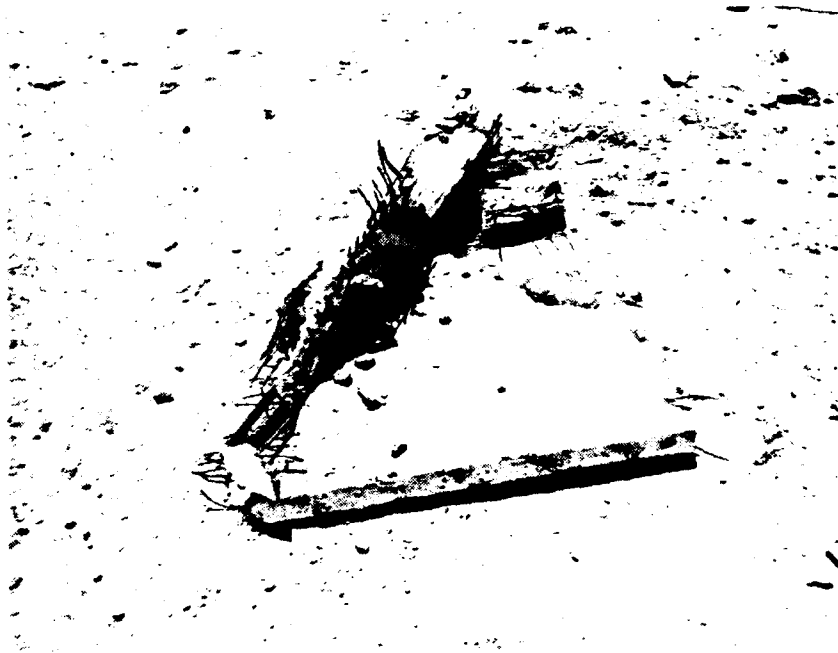
A section of the left wingwall was found connected to a section of the left front wall and resting 11 m in front of the structure (Fig. 77). Only the outer portion of the left wingwall beyond the personnel door opening was found intact on its foundation. A failure plane ran diagonally upward and away from the upper corner of the opening (Fig. 78). All the reinforcing bars crossing the failure plane were found to be broken. This failure plane corresponded to one of the cracks in the left wingwall noted following the PAS-1 test (see Section 3.0).

Figure 77. Part of left wingwall and left front wall, PAS-3.

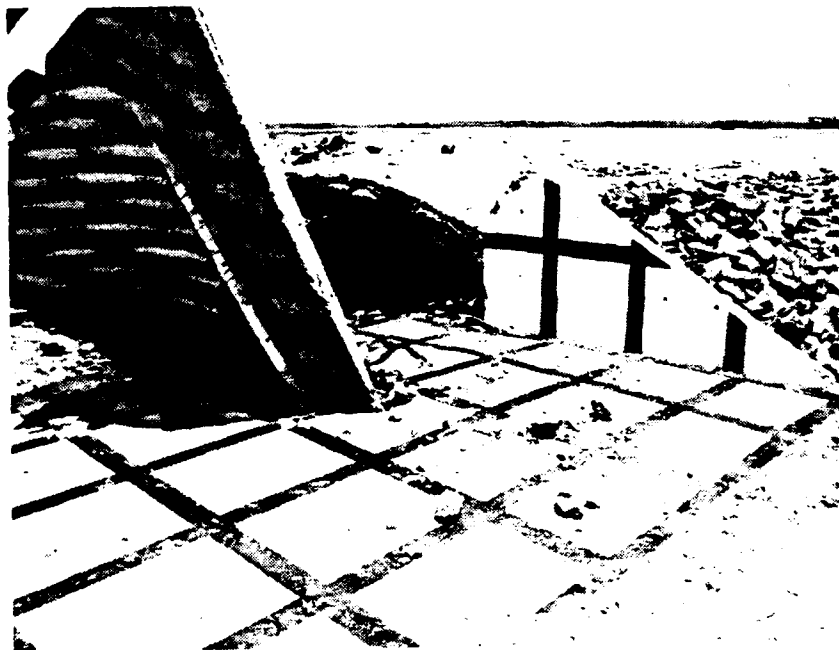
Figure 78. Left wingwall, PAS-3.

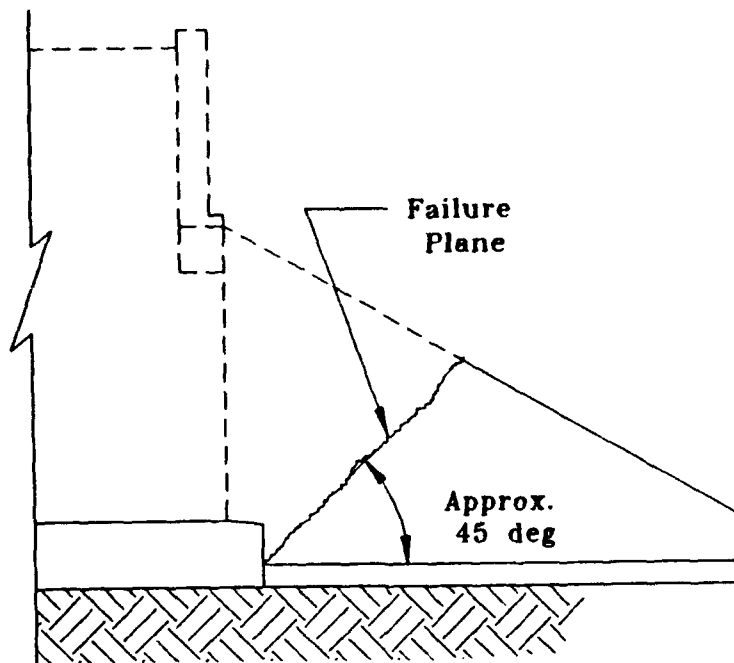
A large section of the arch fell back onto and covered the right wingwall. The high-speed photography suggests that the right wingwall failed in a manner similar to that of the left wingwall. However, the failure plane in this wall ran diagonally upward and away from a point near the base of the front wall foundation (Fig. 79).

Figure 79. Elevation: Right wingwall failure plane, PAS-3.

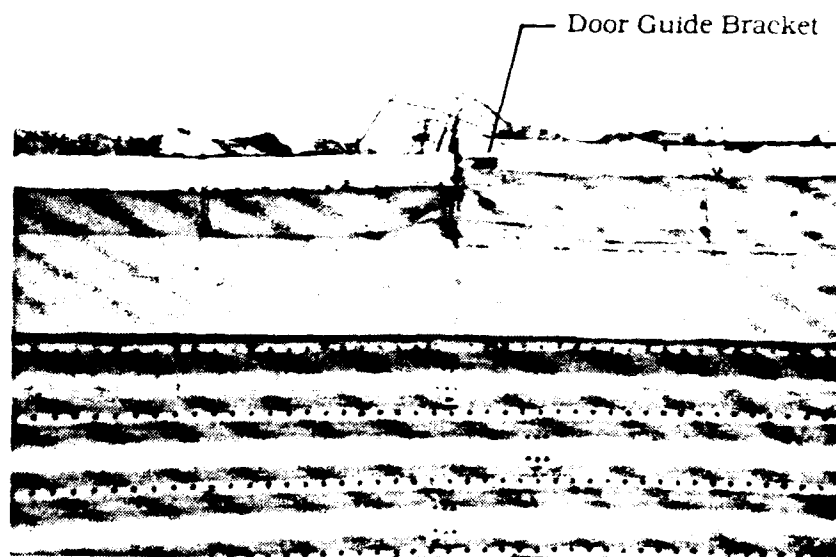
Two major breaks were observed in the welds joining the sections of the steel door frame at the top of the front door opening. The broken welds were located adjacent to each of the two brackets located along the front edge of the door slot (Fig. 82). Significant damage also occurred to the concrete in the front parapet at these two locations. No break occurred in the welded joint near the location of the third bracket, which was broken off in the PAS-1 test (Fig. 83). There was also no damage to the parapet concrete at this location.

Figure 82. Welded joint in steel plate liner and parapet damage at location of door guide bracket, PAS-3.

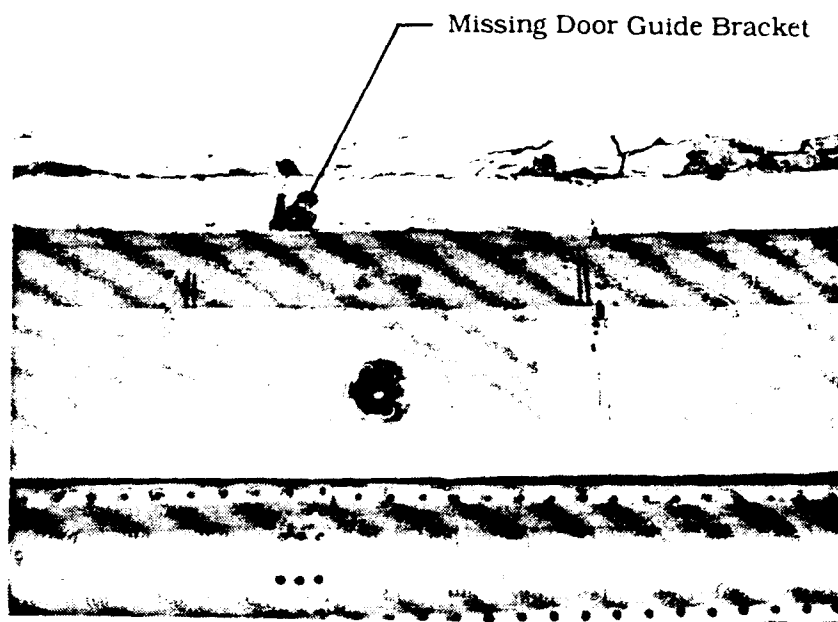
Figure 83. Steel plate liner and parapet at location of missing door guide bracket, PAS-3.

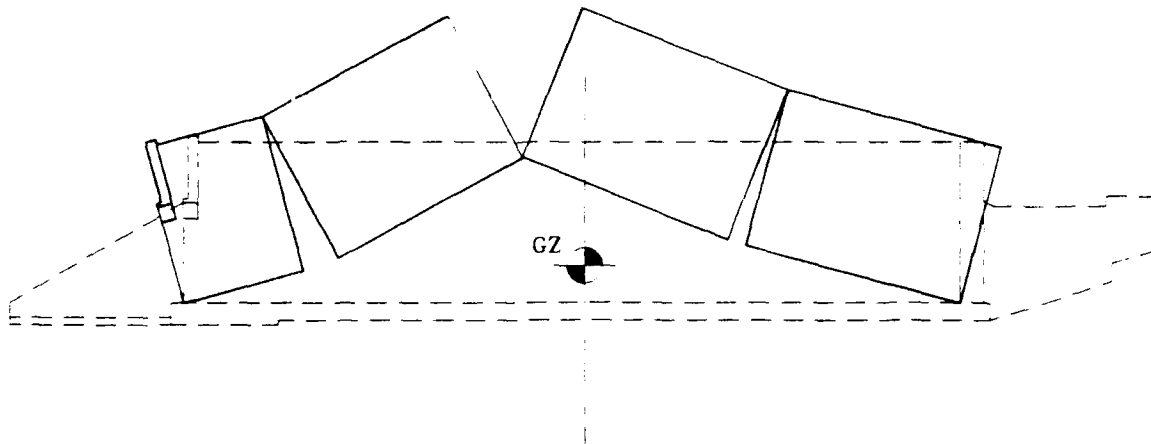
The first detectable upward movement at the crown of the arch occurred at about 6 ms, and the first venting of gases at the crown was observed at 20 ms. Venting of gases along the springline of the arch began at about 28 ms; the major breakup of the arch began at about 34 ms. The arch was broken into seven large sections, which were launched vertically upward at gradually increasing velocities (Fig. 84). Analysis of the high-speed photography indicates the front portion of the arch was moving upward at a velocity of 9.4 m/s at 30 ms, 11.3 m/s at 50 ms, and 14.2 m/s at 100 ms. The upward velocity of the middle portion of the arch was 18.0 m/s at 30 ms, 22.7 m/s at 50 ms, and 23.1 m/s at 100 ms. The rear portion of the arch was moving upward at a velocity of 13.9 m/s at 30 ms and 15.0 m/s at 50 ms. Because this portion was obscured by smoke and other detonation products, its velocity could not be determined at 100 ms. These velocities were averages for large pieces of debris, which rotated about horizontal and vertical axes while moving upward. They are higher than those indicated by integrated accelerometer records. The trajectory of the larger pieces of debris was nearly vertical, and all seven large sections of the arch fell back within the limits of the structure foundation and the perimeter of the rock rubble berm (Fig. 85). The maximum height

(a) Crack Pattern.

Figure 84. Breakup of the arch, PAS-3.

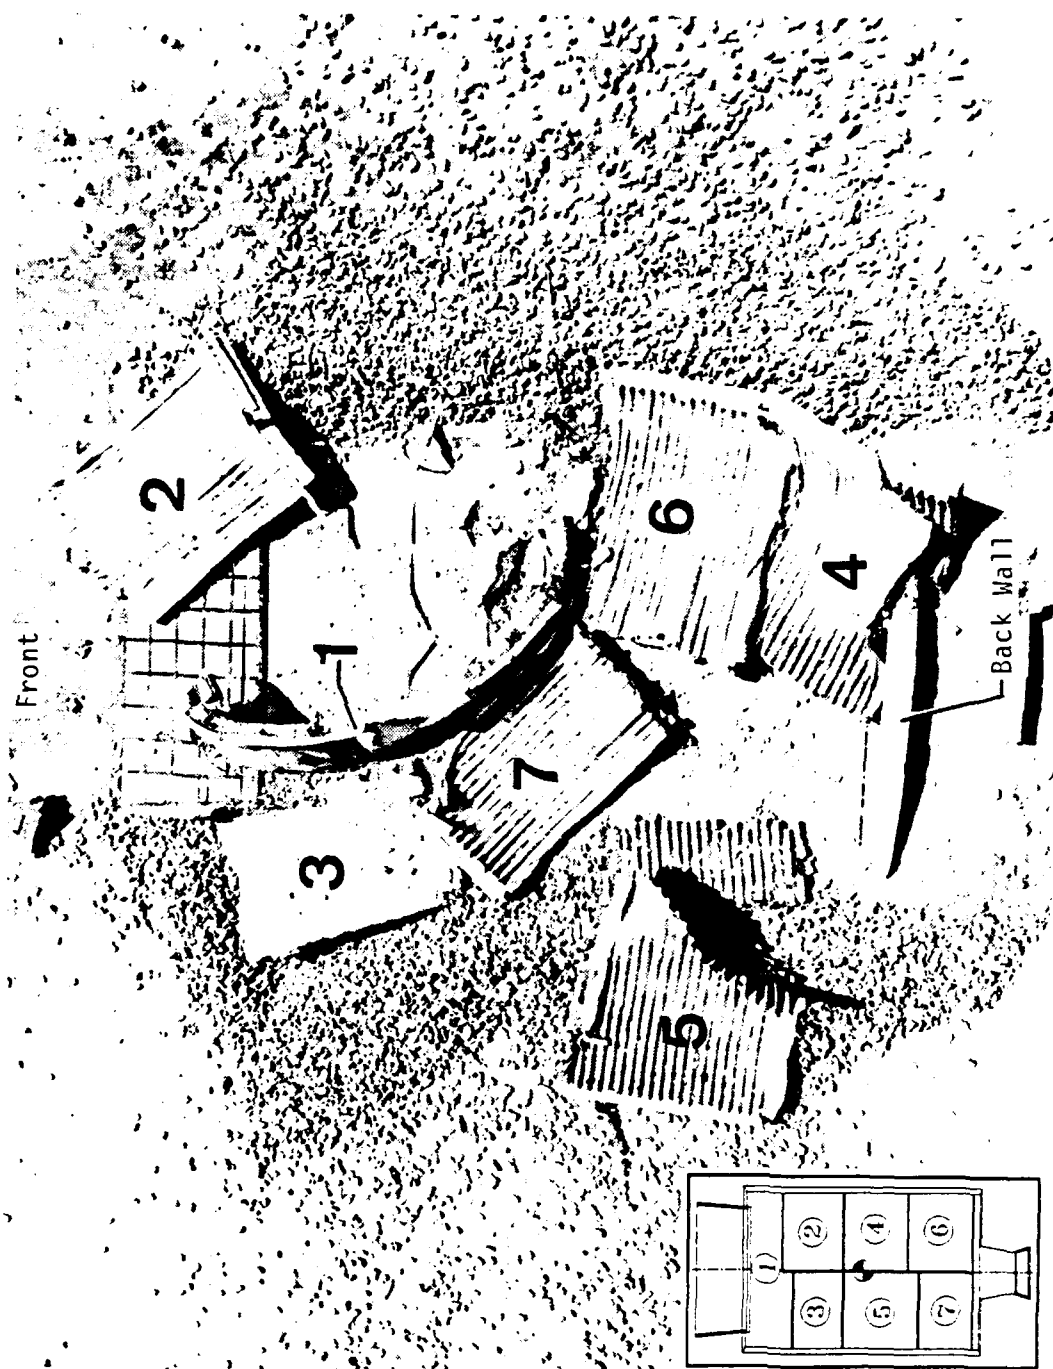
Figure 85. Posttest overhead view of PAS-3 test structure.

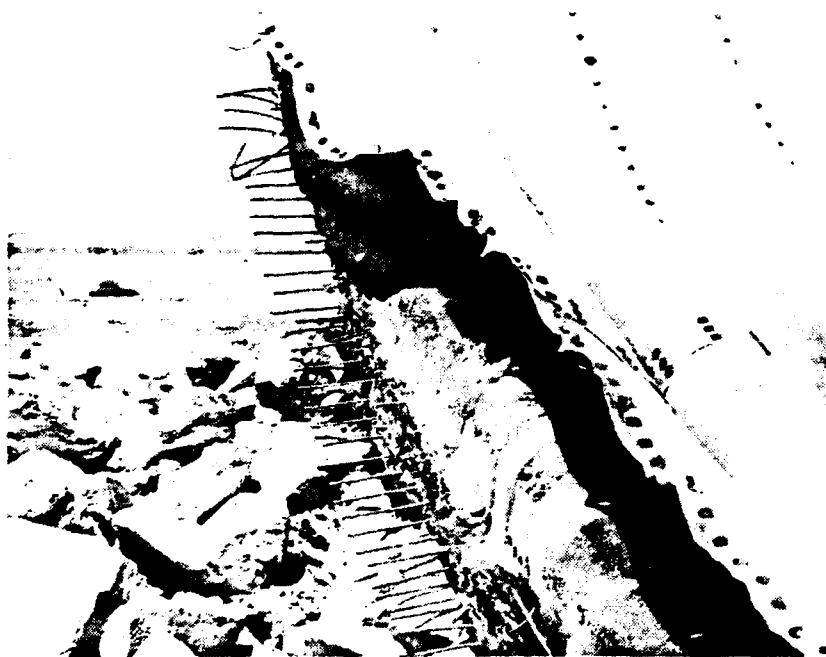
A study of the seven arch sections revealed several common features. Failure in the transverse direction always occurred along a bolted liner joint. At the failure line, the corrugated liner material was almost always pulled over the nut of the bolt (Fig. 86). In only one instance, between Sections #2 and #1, was there some edge tear-out of the bolts (Fig. 87). Examination of the transverse failure line revealed a tension failure of the concrete. Between Sections #2 and #4, #3 and #5, and #4 and #6, the failure plane occurred near a line of splices in the reinforcing bars, and the bars pulled out of the adjacent piece (Fig. 88). Between Sections #1 and #2, #1 and #3, and #5 and #7, the reinforcing bars failed in tension at the fractured face of the concrete (Fig. 89).

Figure 86. Typical bolt pull-out at liner joint, PAS-3.

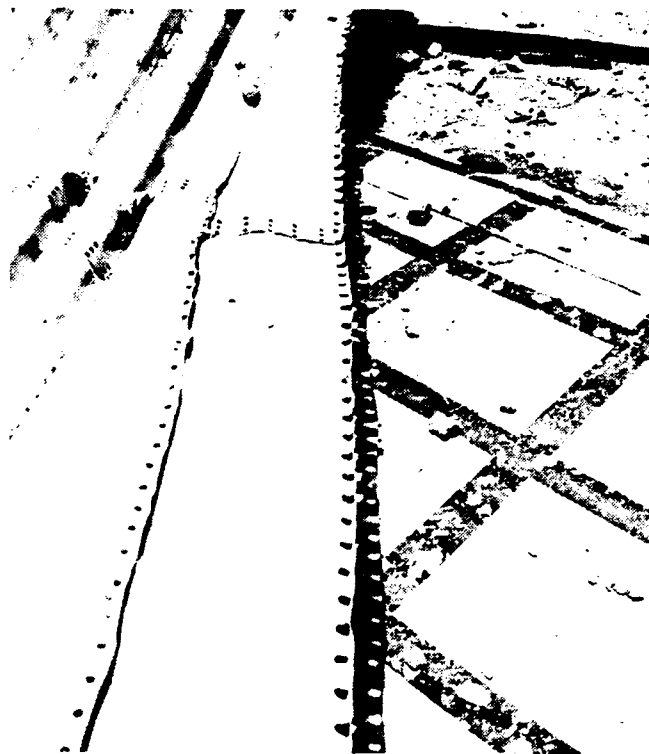
Figure 87. Edge tear-out of bolts in liner of Section #2, PAS-3.

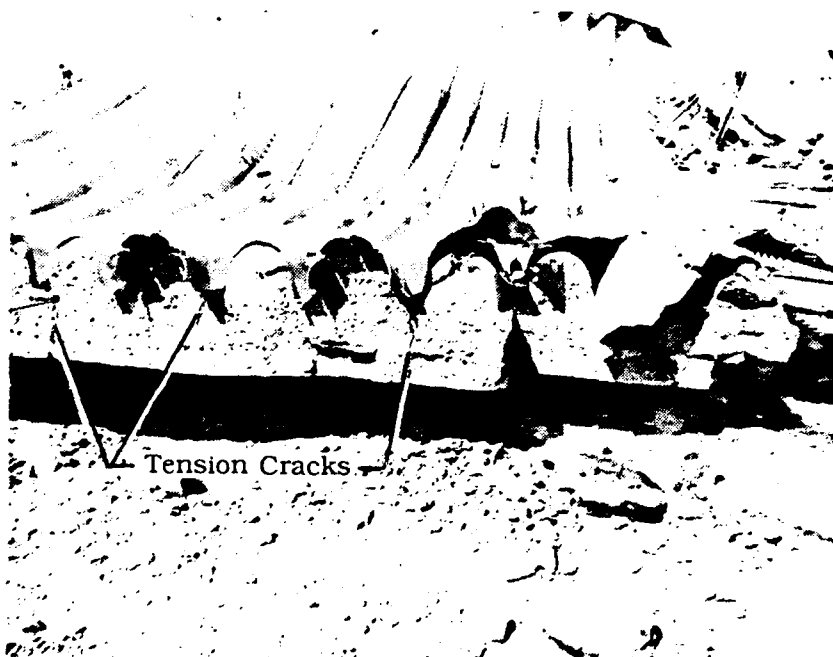
An examination of the fractured face of the longitudinal failure plane revealed tension cracks at almost every transverse liner joint (Fig. 91). The cracks ranged from hairline to several millimeters in width. There were significantly fewer cracks at the base edge of the arch. These cracks were also narrower in width than those elsewhere on the arch and appeared to be randomly spaced along the edge.

Figure 91. Tension cracks, PAS-3.

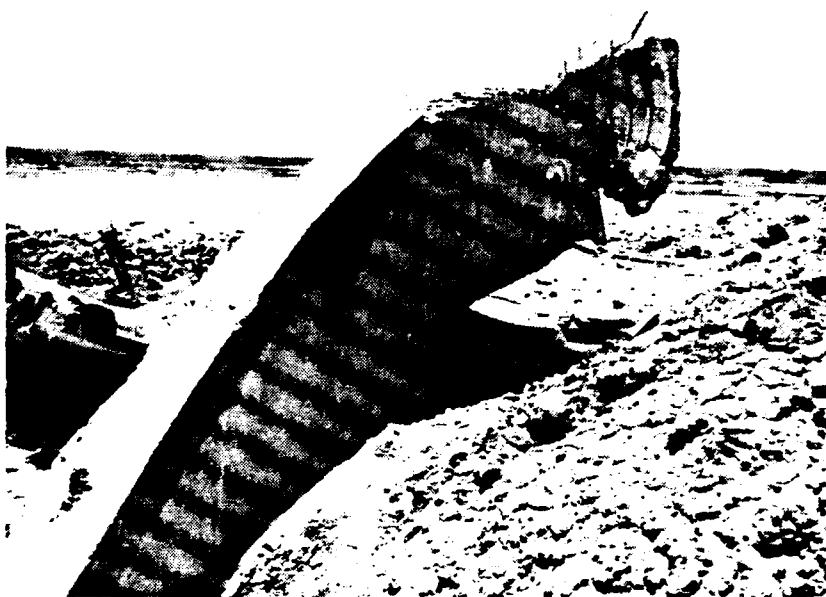
The backwall was found generally intact and upright on its foundation following the test. A slight outward tip was noted. It also appeared that it had been displaced backward about 50 mm. The earth against the outside of the backwall appeared to have been pushed away from the wall (Fig. 93). The position of the soil indicates a larger transient outward motion of the whole backwall and a rebound to its final position.

Figure 93. Displaced earth backfill, PAS-3.

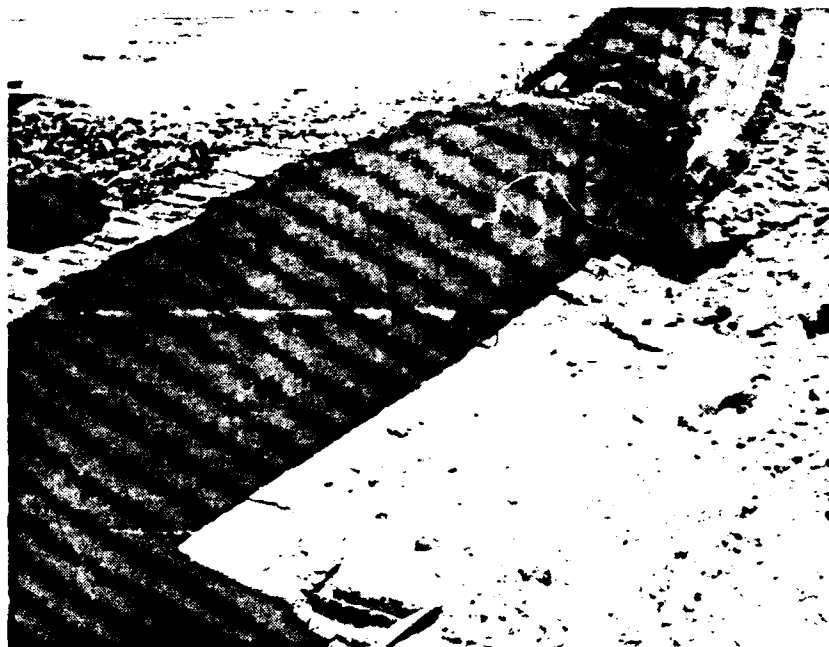
The arch portion had separated from the top edge of the backwall at the inside interface, breaking every dowel bar (Fig. 94). The failure plane then proceeded along a vertical plane corresponding to the step in the joint (Fig. 95). All the horizontal reinforcing bars crossing the vertical failure plane were also broken. Along the top one-third of the backwall the concrete covering the reinforcing bars was broken off. A crack corresponding to the inside interface was observed all along the top edge on the back surface of the wall (Fig. 96).

Figure 96. Back view of backwall, PAS-3.

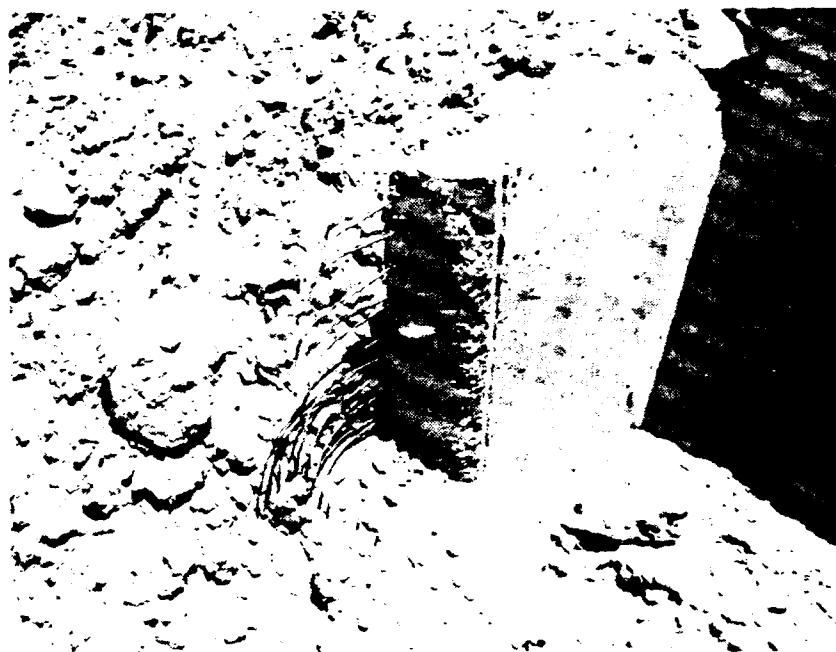
The entire endwall of the exhaust port broke away from the sidewalls of the exhaust port (Fig. 98). Several large pieces were found as far as 32 m behind the structure (Fig. 99). The exhaust port experienced severe cracking and damage at every intersection of the structural elements (Fig. 100). Cracking to a somewhat lesser degree was also observed in the faces of the structural elements themselves. Despite the severe damage at the corners, all of the components, with the exception of the endwall, remained attached to each other and/or the backwall.

Figure 98. Exhaust port endwall failure at sidewall, PAS-3.

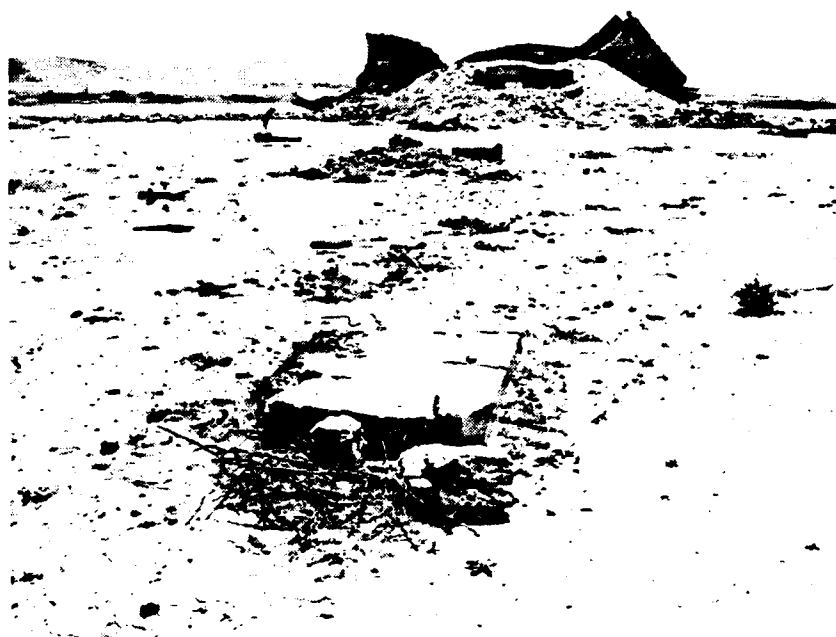
Figure 99. Final position of exhaust port endwall, PAS-3.

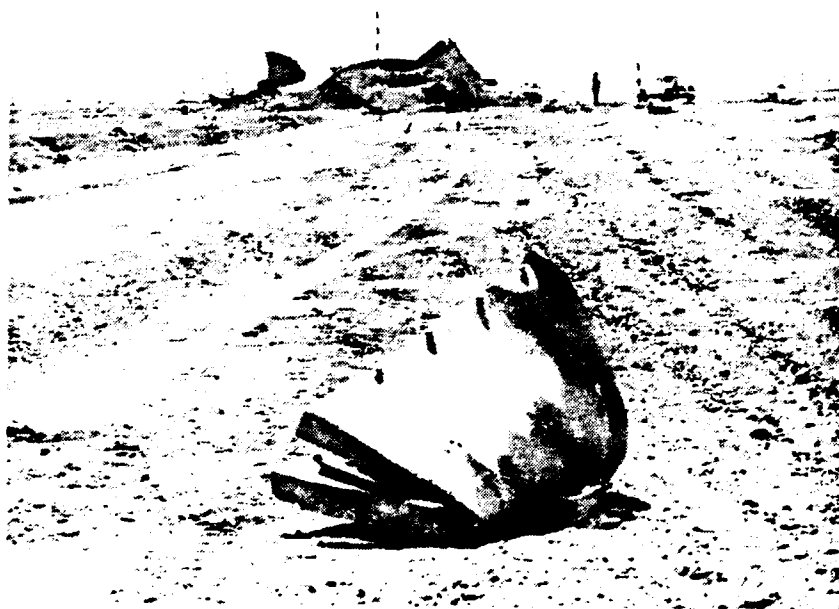
The two exhaust port doors were blown upward and out the back of the exhaust port and were found at distances of 76.5 and 155.7 m behind the structure. Both doors were bent about a horizontal line (Fig. 101). Abrasions on the doors indicate that they probably struck the exhaust port endwall as they were blown out. The two steel door frames originally embedded in the floor and the walls and roof of the exhaust port were also found in several pieces behind the structure (Fig. 102). The headed anchor studs used to secure the door frames to the exhaust port concrete had been pulled out of the concrete but remained welded to the frame. In some cases, the steel angles at the top and bottom of the doors were found still welded to the frame; in others the welds had failed and the angles adhered to the door.

Figure 101. Exhaust port door, PAS-3.

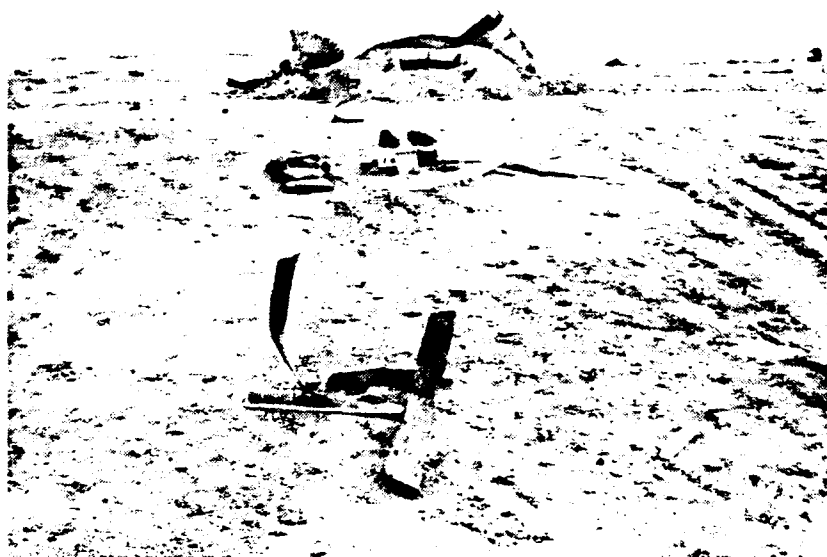
Figure 102. Exhaust port door frame, PAS-3.

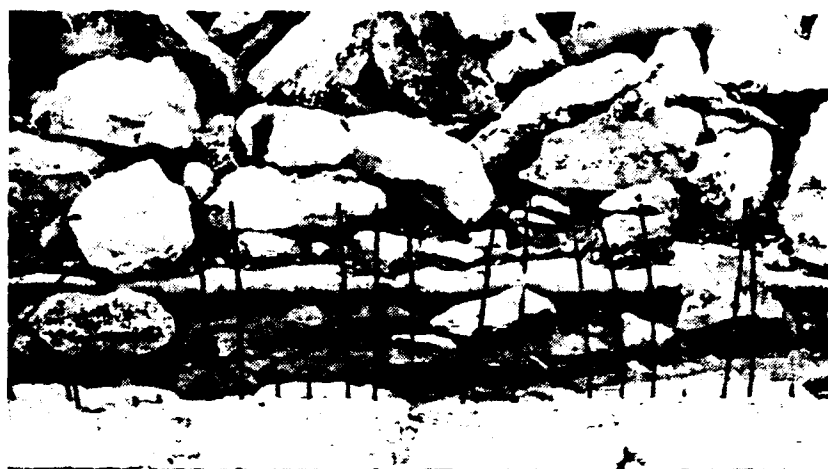
The floor slab was found in place against the arch foundation, with little indication of vertical displacement between the two components (Fig. 103). The floor was heavily damaged due to the impact of the large arch sections falling back down. A portion of a crater caused by the explosive charge was seen in the surface of the floor slab. The

Figure 103. Broken dowel bars in top of the arch foundation, PAS-3.

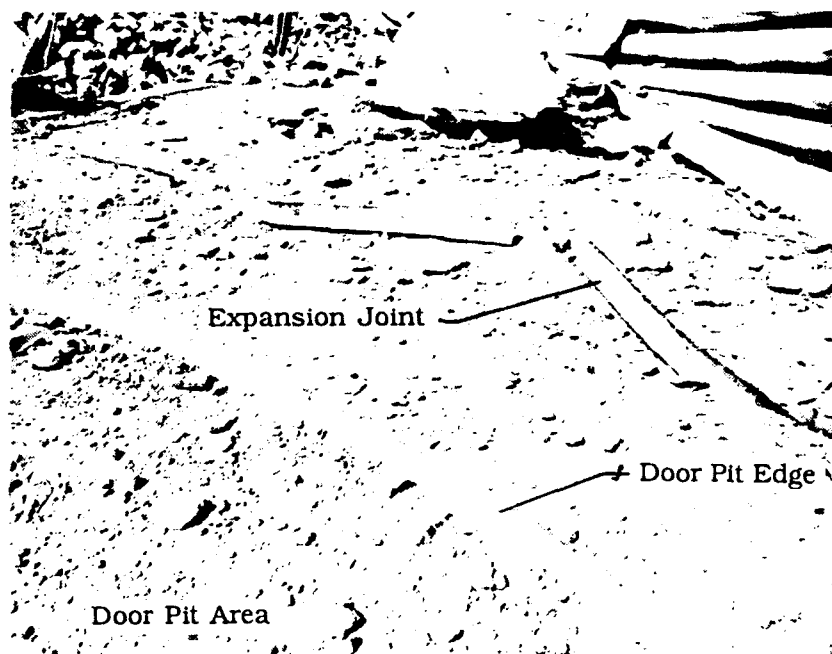
The joint between the floor slab and the heavily reinforced portion of the floor slab containing the door pit showed a relative separation of 25 mm of the two components. The fiber board expansion joint material was blown out of the joint for most of its length (Fig. 104).

Figure 104. Floor slab expansion joint, PAS-3.
